Manhole Inspection Summary

Manhole # S41I__035MH

Location Address: **front of 324 exerter st**

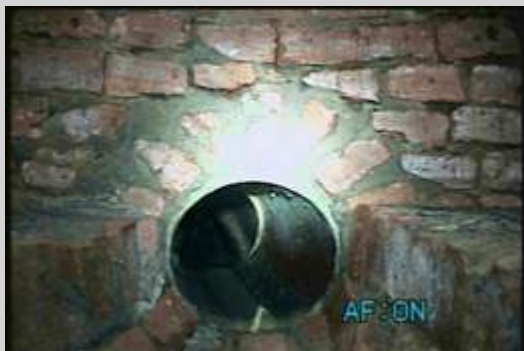
3 O'Clock Inflow

8 in. Circular Gravity Sewer
Pipe In @ 3 O'Clock

Pipe Material: **Clay** ☐ Pipe Lined

Infiltration: **None** Pipe Seal Cond: **Unknown**
